Manhole Inspection Summary

Manhole # S37C__024MH

Insp Date: **10/20/08 10:40 AM**

Location Address: **541 hillen st**

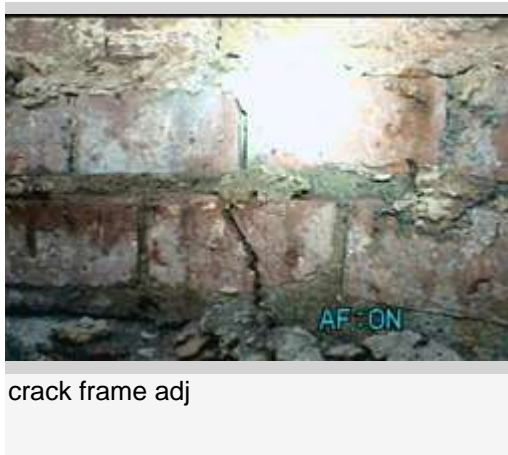
Defect 3

Condition: ☐ Sound ☒ **Cracked** ☐ Root Intrusion ☐ Loose Brick ☒ **Deteriorated**

crack frame adj

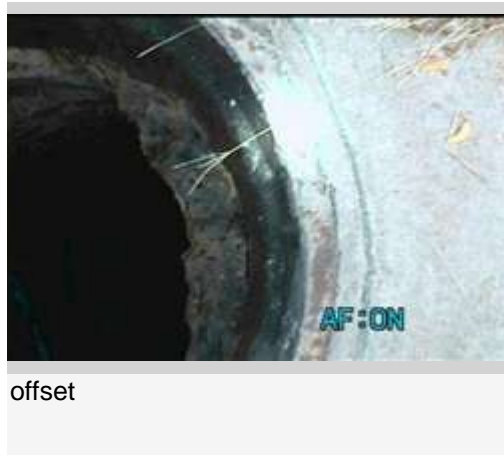
Defect 2

Frame Offset: **2.5** (in.) Condition: ☒ Sound ☐ Cracked ☐ Leaks

offset

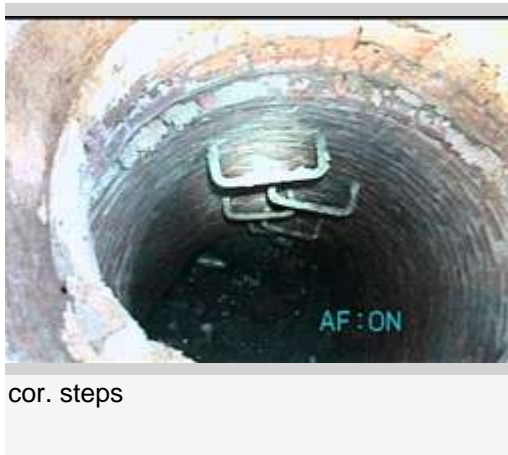
Defect 1

Steps Count: **6** Missing: **0** ☒ **Corroded**

cor. steps

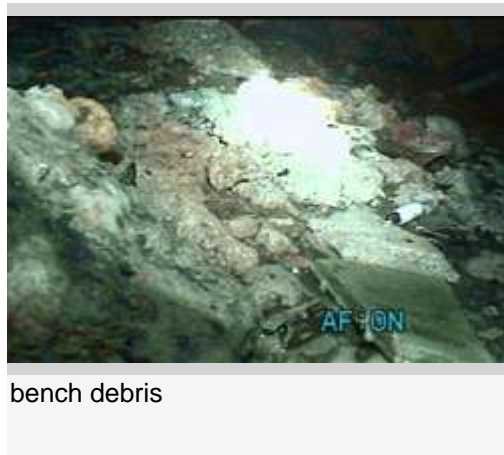
Defect 4

Condition: ☐ Sound ☐ Cracked ☐ Root Intrusion ☐ Deteriorated ☐ Leaks ☒ **Debris**

bench debris

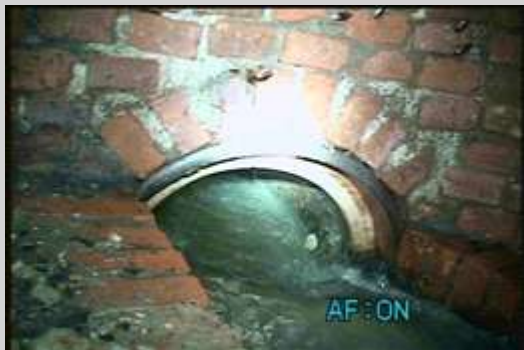
12 O'Clock Outflow

15 in. Circular Gravity Sewer
Pipe Out @ 12 O'Clock

Pipe Material: **Clay** ☐ Pipe Lined

Invert Depth: 11.75 (ft.) Flow Characteristics: **Fast**

Deposits: ☒ None ☐ Mud ☐ Sludge ☐ Debris ☐ Grease

Infiltration: **None** Pipe Seal Cond: **Unknown**

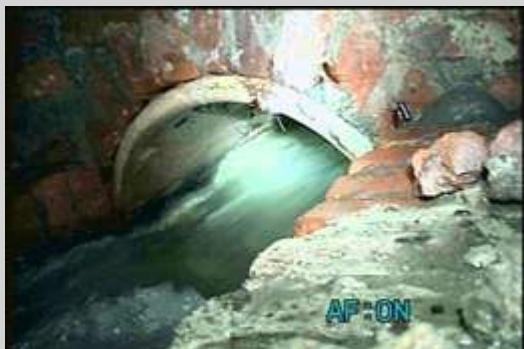
6 O'Clock Inflow

15 in. Circular Gravity Sewer
Pipe In @ 6 O'Clock

Pipe Material: **Clay** ☐ Pipe Lined

Invert Depth: 11.60 (ft.) Flow Characteristics: **Fast**

Deposits: ☒ None ☐ Mud ☐ Sludge ☐ Debris ☐ Grease

Infiltration: **None** Pipe Seal Cond: **Unknown**
